# New York State Department of Transportation

## Yellow Flag NB2228W017

Flag Date: March 28, 2022

**BIN: 1065318**

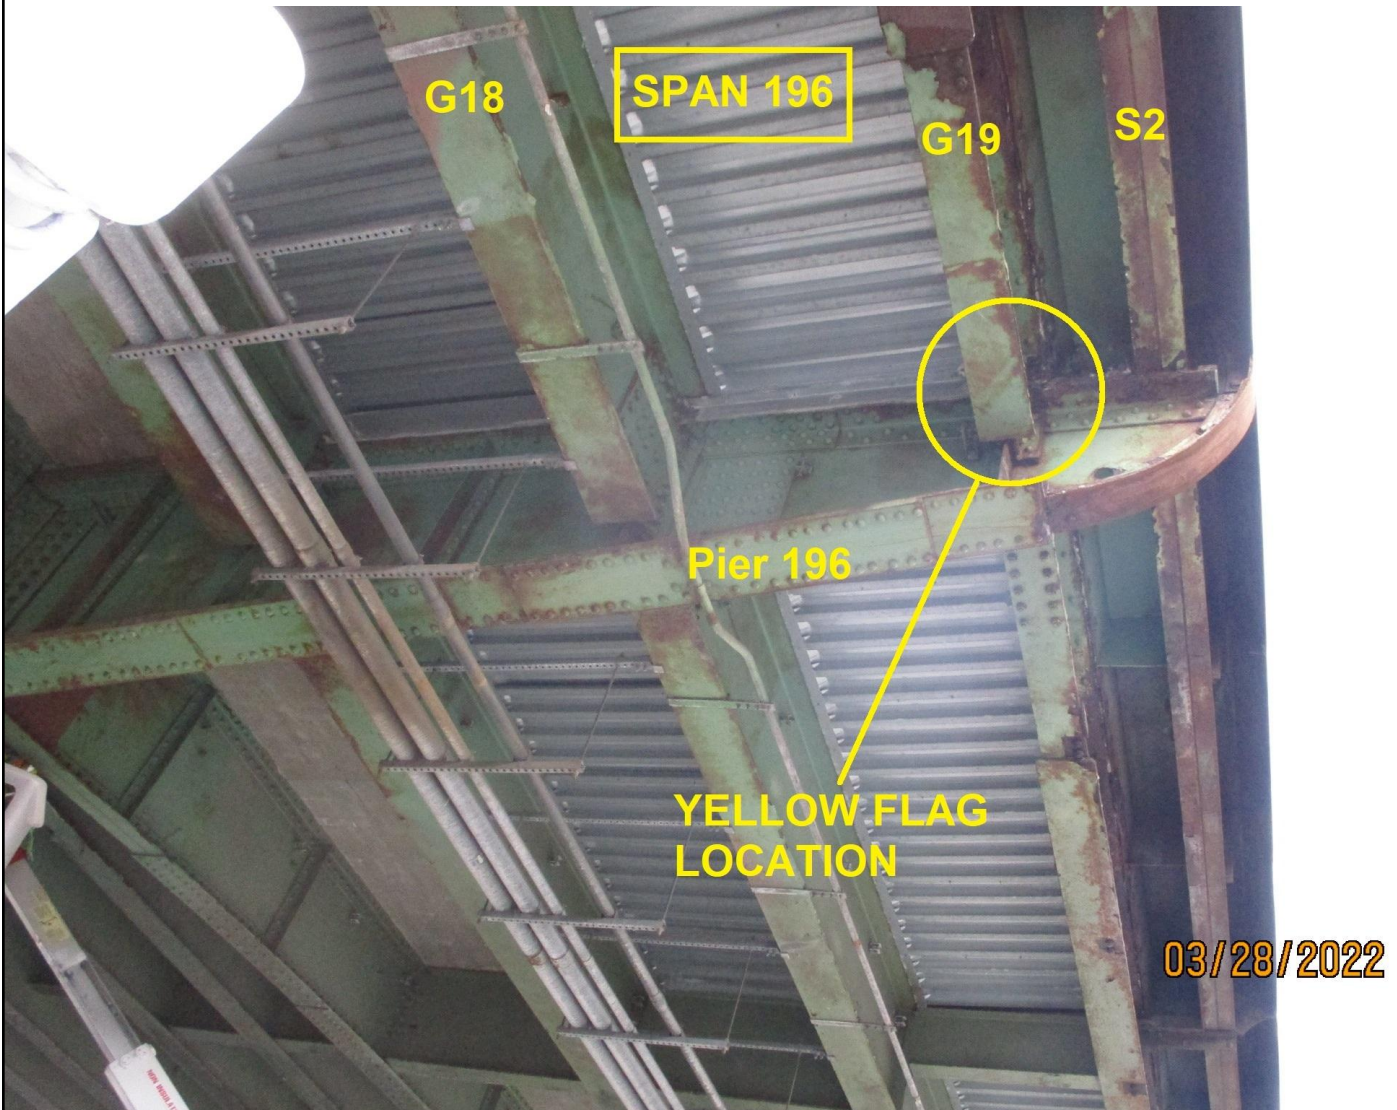
Photo Number: 1

**Attachment Description:** Photo 310-9777 - General view of the flagged condition at Girder G19 in Span 196 at Pier 196. Looking End.

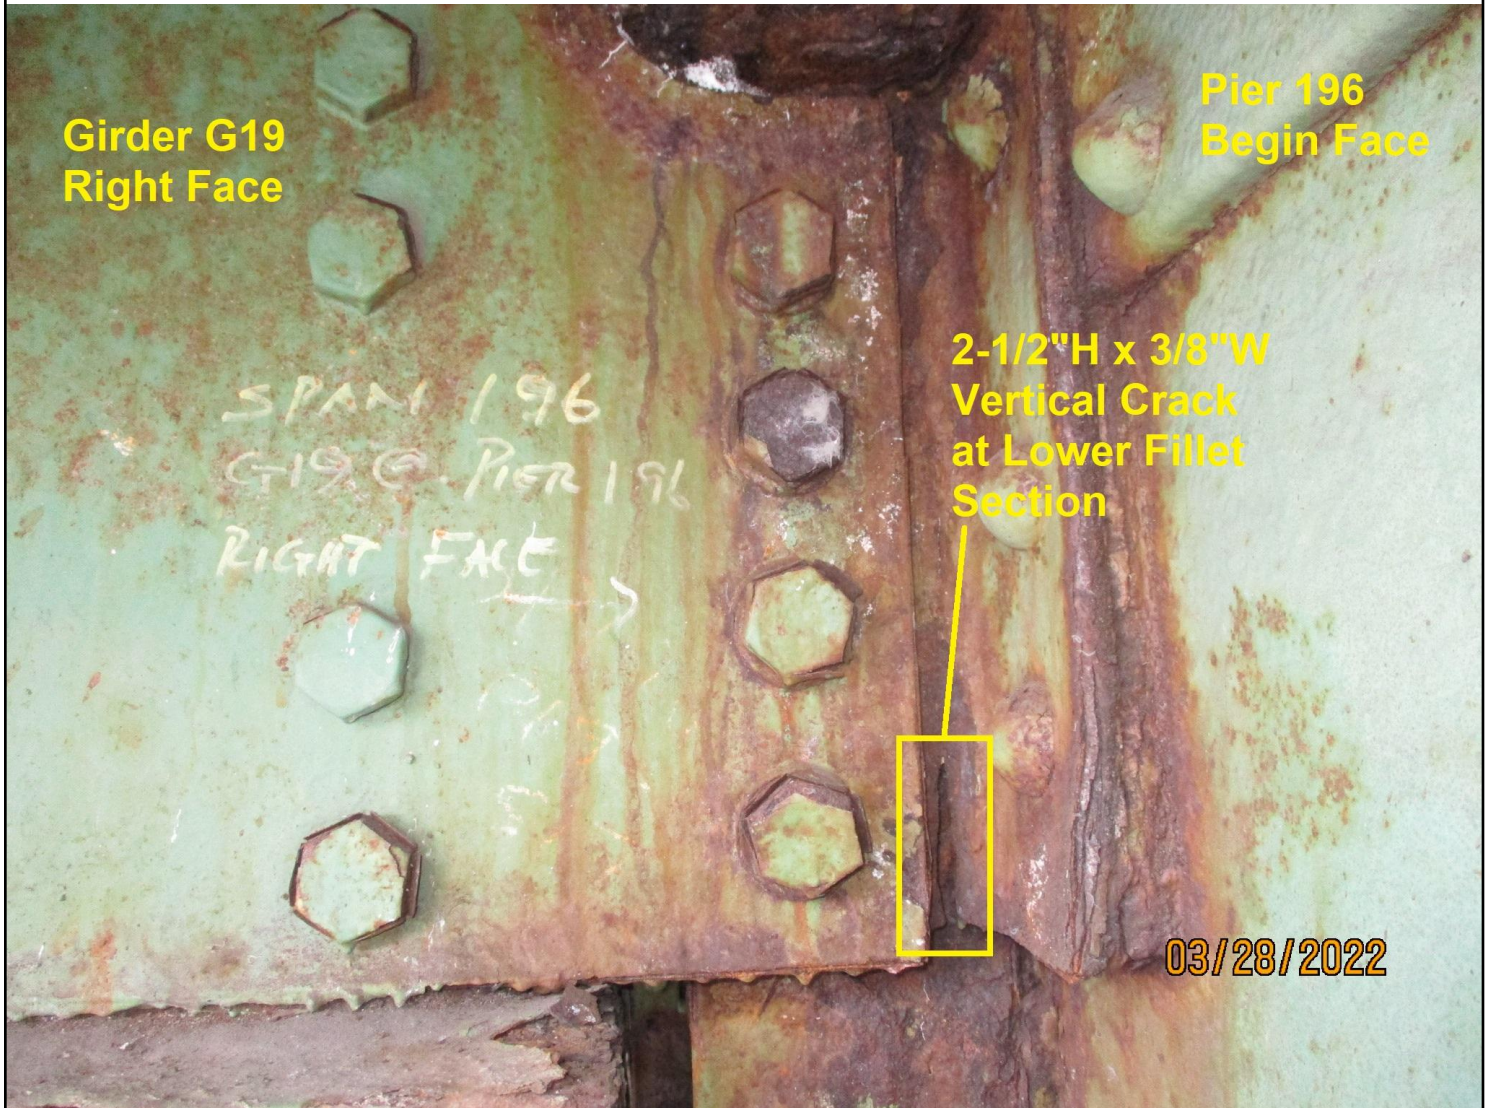
Photo Number: 2

Description: The right clip/connection angle of Girder G19 connection to pier cap at Pier 196 exhibits a 2-1/2" long vertical crack x 3/8" wide at the lower fillet section (deterioration induced cracking). The remaining section of the right clip connection angle has heavy corrosion and up to 3/4" pack rust between the connection at the pier cap.

**Attachment Description:** Photo 310-9766 - The right connection angle of Girder 19 connect to the pier cap at Pier 196 exhibits a 2-1/2"H x 3/8"W vertical crack at the lower fillet section. Looking Left.

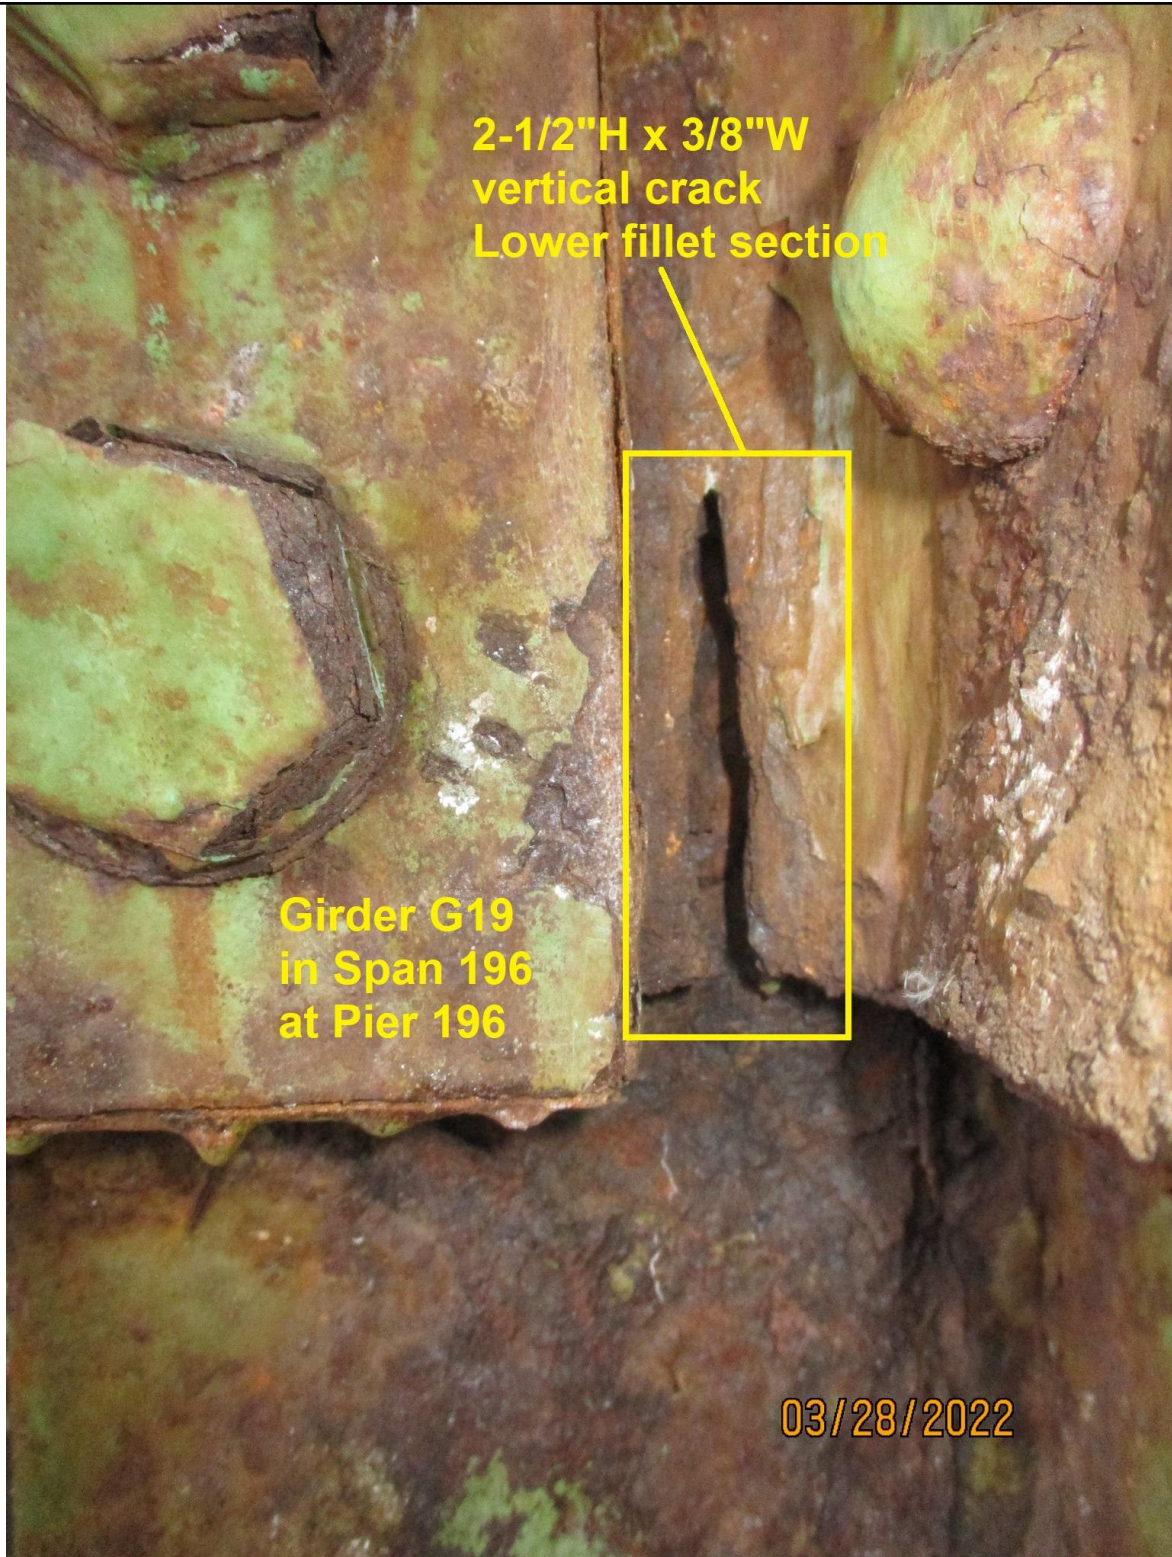
Photo Number: 3

**Attachment Description:** Photo 310-9767 - Close-up view of the right connection angle of Girder 19 connect to the pier cap at Pier 196 exhibits a 2-1/2"H x 3/8"W vertical crack at the lower fillet section. Looking Left.

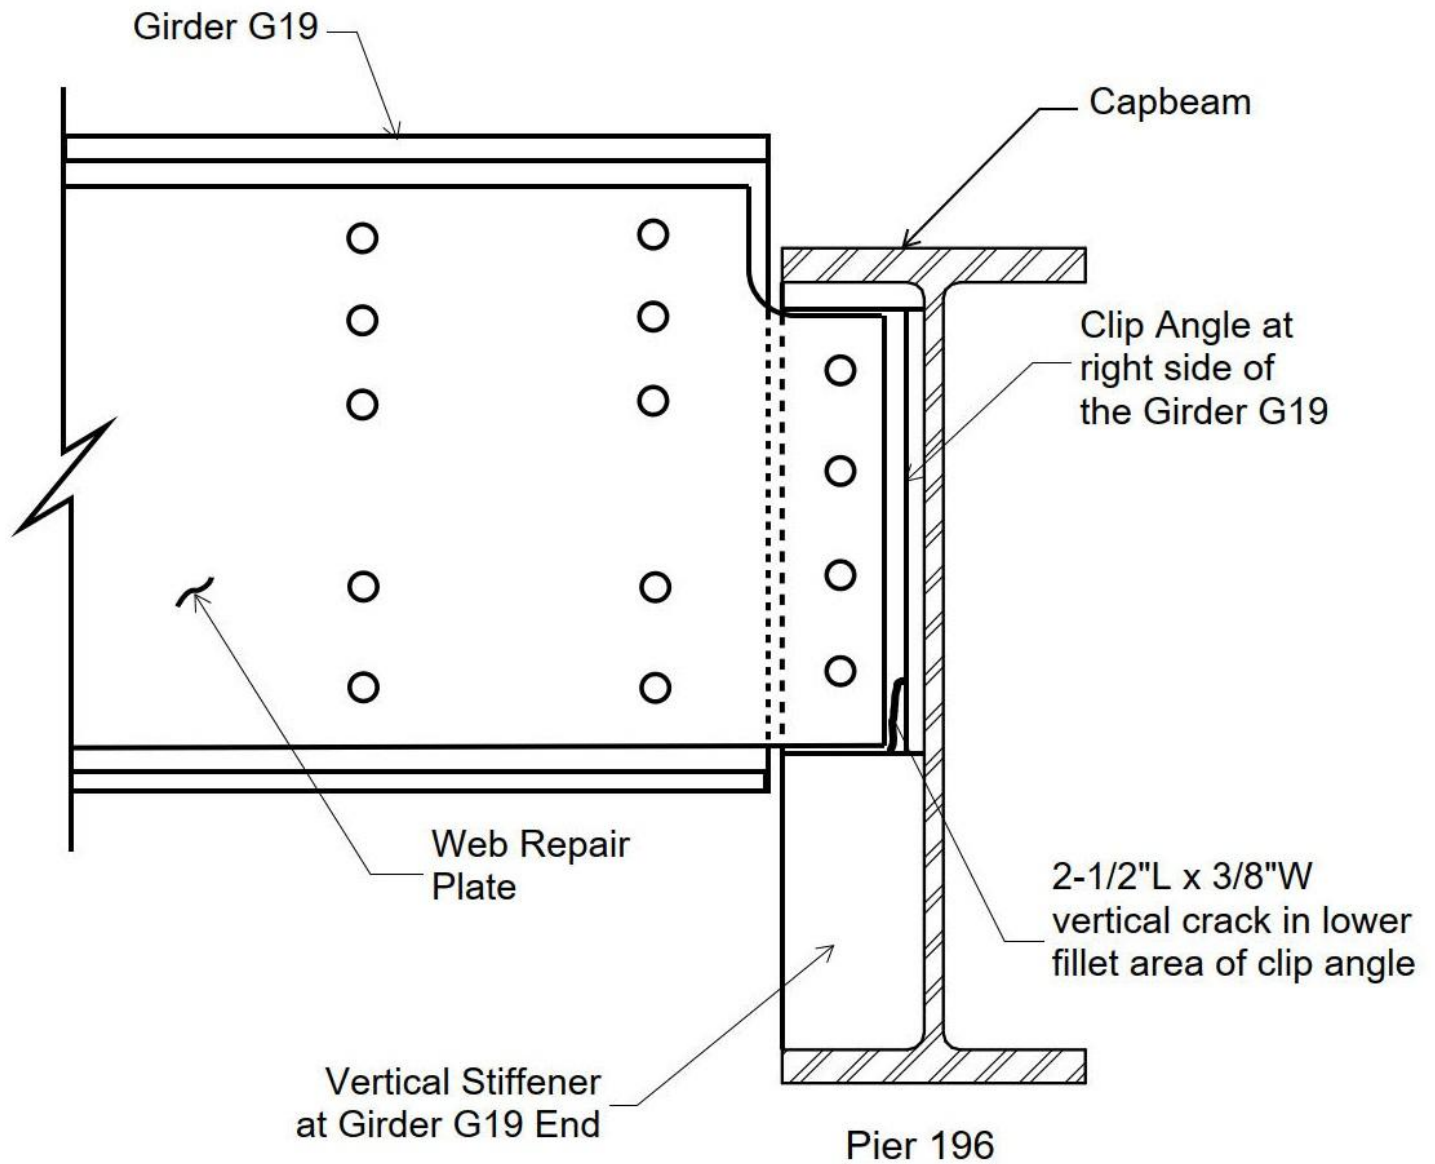
**SPAN 196, GIRDER G19 BEAM END AT PIER 196**  
**(LOOKING LEFT)**  
**N.T.S**

*Attachment Description: SN196 G19 at Pier 196 Sketch*

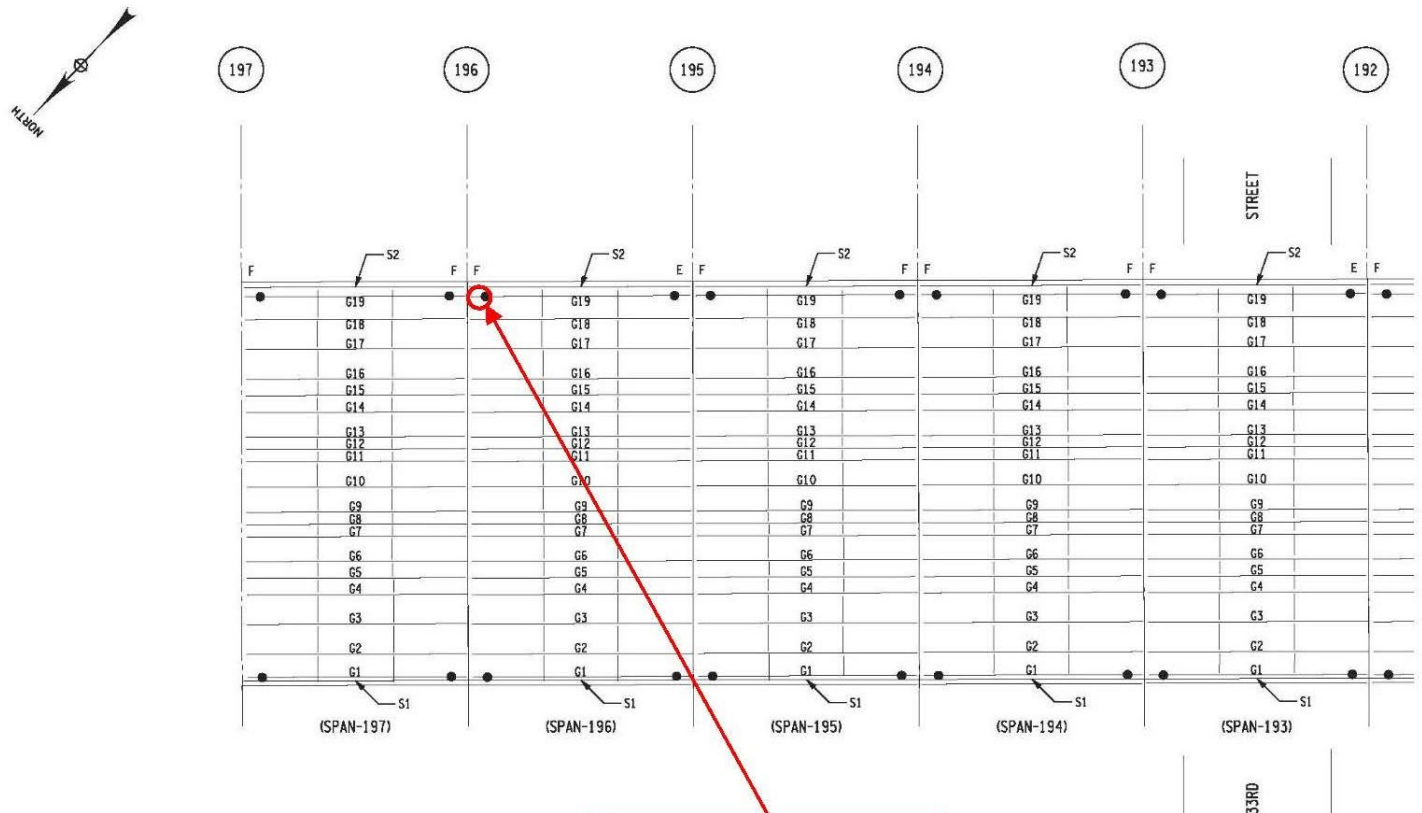
**YELLOW FLAG  
LOCATION  
No. NB2228W017**

**Attachment Description: SN196 G19 at Pier 196 Framing**
